THE PRINCE GEORGE'S COUNTY GOVERNMENT

Re: Municipal Storm Drain
Acceptance Program
Town of University Park

MAINTENANCE REPORT

SUBDIVISION NAME University Park STREET: Wells Pkwy 200' SHEET NUMBER: 208 NE 3

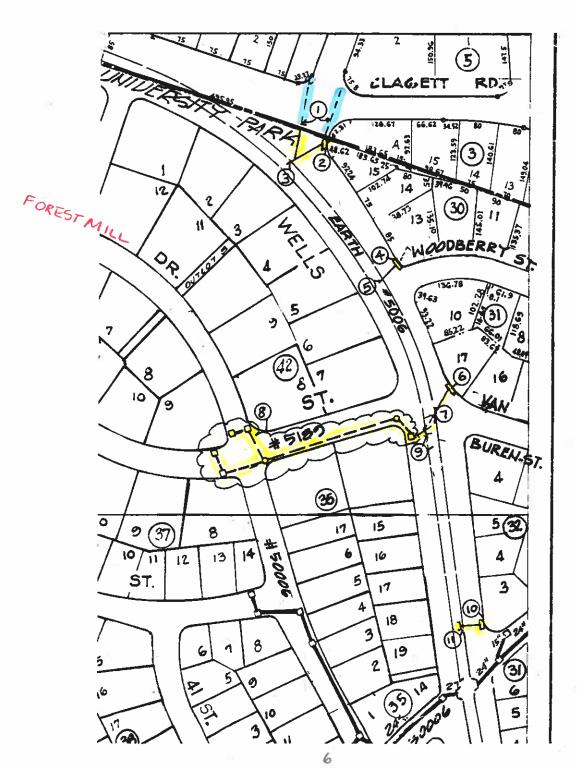
SUBDIVISION NAME University Park. STREET: Wells Pky, Van Buren St., Forest Hill Dr. (10f2)

NUMBER	TYPE	PROBLEM	LOCATION
<i>I</i> = ==	Inflow pipes ent System from ou University Park	\sim	Wells PKwy, Clagett Rd
2 4 6 10	Curb inlets	not shown on 200' sheet	Wells Pkwy
3579 11	outfalls	not shown on 200' sheet, no endwall structur	earthen channel along Wells Pkwy 15

8 Storm drain system none Van Buren St. of numbered 5189 Forest Hill Dr. enclosed in ED

Recommendation: accept all the storm drain shown that falls within University Park.

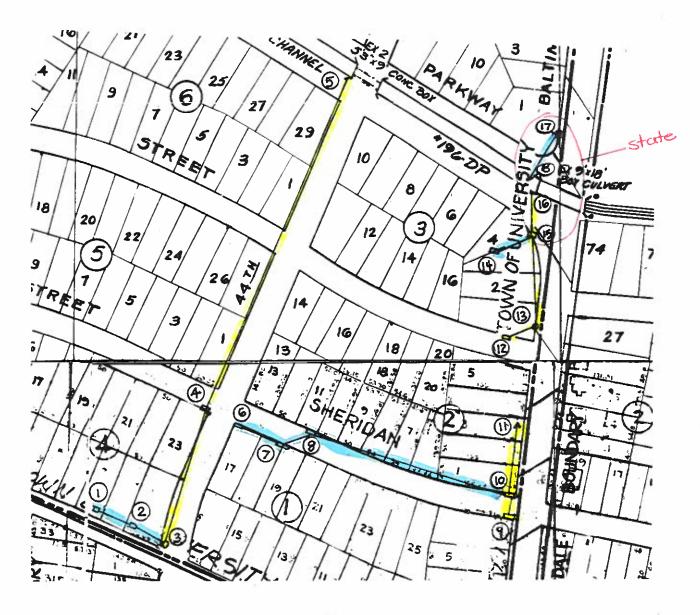
SUBDIVISION NAME University Park STREET: 44th, Sheridan St., Route 410, Underwood St., Wells PKWU 200' SHEET NUMBER: 208 NE4 Tuekerman St. (1055)

200 011	EE! NUMBER. 208	NET TUBERTY	er 5 (20) =)
NUMBER 1,2	TYPE yard inlets	problem not built to web stds, located on private property	LOCATION East-West Hwy
3 3	manhole	(not on 200' sheet) (not shown on 200' sheet), on private nmerty, SHC: top	44th and East- West Hwy
4	curb inlet	may be on state proper (not shown on 200' sheet)	Sheridan St.
5	outfall into bridge wingwall	none	44 th
6,7	curb inlet	completely clogge with dubris (not shown on 20 sheet)	00'
8,9,10	curb inlets	none (not on Zoo'sheet)	Underwood St.
11	Stormdrain	Unable to determine outfall location, pipe doesn't connect structures 12 or 13 not shown on 200'	at Sheet)

NUM	BER TYPE	PROBLEM	LOCATION
12	curb inle	t none (not shown on 200' sheet)	Tucker man St.
13	man hole	none (not shown on 200' sheet)	Route 1
ľΨ	curb inlet	located on private property, drains only church parking (not on zoo sheet private system	Church Parking 10+
15	curb inlet		wells PKwy
16	into bridge wing wall	none (not shown on 200' sheet)	wells PKwy
17	wr inlet	located in SHA RIW	Route 1
18	outfall	none (not on 200' sheet)	wells Parkway

Recommendation: Accept the storm drain line down 44th Ame from the manhole at Rt 410 (#3) to the outfall (#5) at the bridge, this includes the inlet at Sheudan St. # (4). Do not accept the yard inlets and associated storm drain pipe (#1 and #2) due to their location on private property and non conformance with standard construction practices).

Do not accept the system on Shudan St. numbered 6,7,8 and associated storm drain pipe to structure 10. The system is completely clagged with debris and has not functioned for an extended time period. The pipe inverts are not visable due to the formation of topsoil in the injuts formed from years of decomposing leaves. After the system is cleaned a determination of the condition of the pipe needs to be made. Since the system has not been functioning and no adverse effects have occured thus far it may be possible the system is not necessary.

Inlets 9 and 10 may be sufficient to convey the storm water on Sheridan st. Accept the Inlets 9 and 10; nowever, during phase I the outfall of the system needs to be determined.

Accept inlet #12 on Tucker man St, manhole #13, inlet 15, and the outfail into the bridge (#16) for maintenance. Do not accept inlet # 14 and the associated storm drain pipe because it's on private property and recieves runoff from the church parking lot only (private septem)

Do not accept inlet 17 because it drains
Route 1. This is the State Highway Administration's
responsibility. The County will maintain the
out fall from the State's system #18; however,
the County will only be responsible for
insuring that the outfall remains free flowing
not for the Structural integrity of the outfall
pipe.

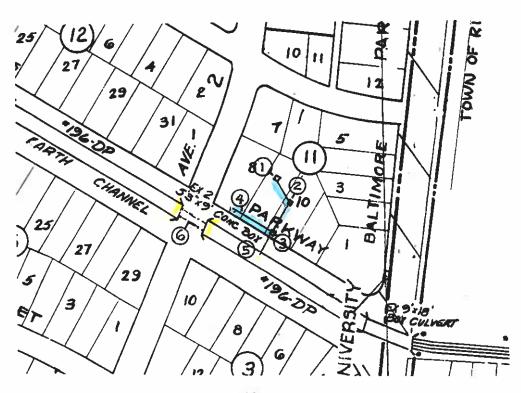
SUBDIVISION NAME University Park STREET: 44th Ave, Wells Pkwy (10f2) 200' SHEET NUMBER: 208 NE4

NUMBER	TYPE	PROBLEM	LOCATION
1,2,3	yard inlets	do not meet	wells Pkwy
		WPB std's, located	$\mathcal{L}_{\mathcal{L}}$
		on private property (not shown on 200' sheet)	
	•		
4	Storm drain pipe	outfalls into struc	ture #3 on wells Pkuy
	· •	but inflow not	¥.
		locatable

NUMBER	TYPE	PROBLEM	LOCATION
5	outfall	none (not shown on 200' sheet)	wells Pkwy
6	Bridge	structure unsafe road closed	44th Ave

Recommendation: Do not accept the system for maintenance (#1 thru #4) due to the following:

a.) Structures do not meet WPB standards.

b) structures located on private property.

Accept for maintenance #5; however, DPW&T. Storm drain maintenance will only be responsible for insuring the outfall remains free flowing, not for structural integrity of outfall pipe.

The (ounty will maintain only the waterway opening of #6 to convey Stormwater, but will not structurally maintain the bridge.

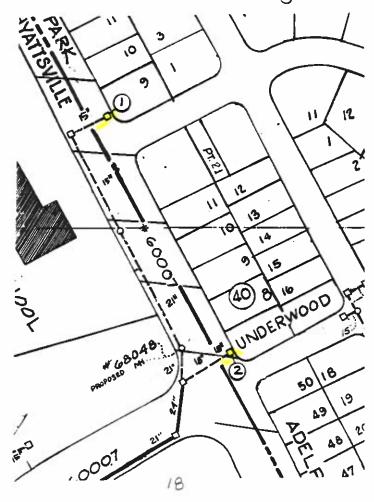
SUBDIVISION NAME University Park STREET: Adelphi Rd. 200' SHEET NUMBER: 208 NE3

NUMBER	TYPE	PROBLEM	LOCATION
1	Curb inlet	none	on Adelphi Rd above
			Van Buren St.
2	curb inlet	none	on Adelphi Rd above
			Underwood St.

Recommendation: Accept the part of 60007 (inlets land 2) that are within University Park.

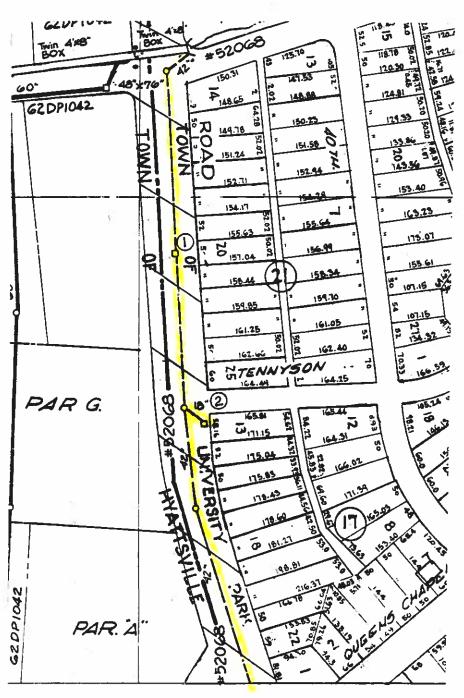
SUBDIVISION NAME University Park STREET: Adelphi Rd.

inlet on Adelphu Rd was not locatable during field investigation

Z Curb met no problem located as Showr on Adelphi Rd.

Accept curb inlet along Adephi Rd for maintenance All storm drain in road R/W.

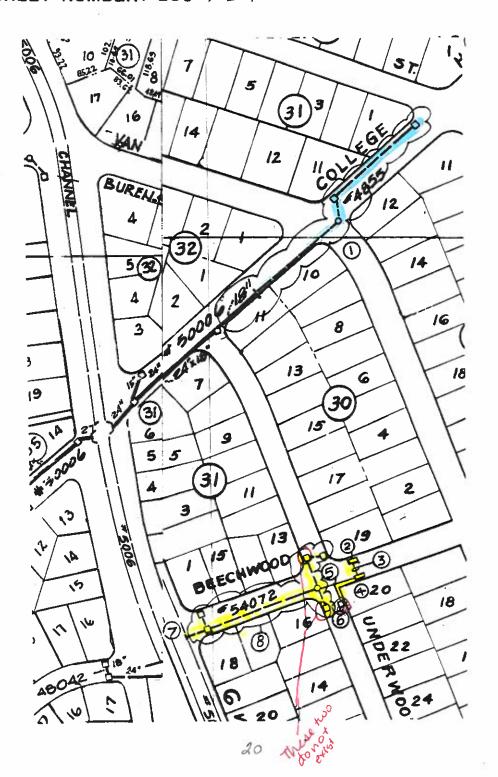
SUBDIVISION NAME University Park STREET: College Heights Dr., Buchwood Rd., Underwood Rd. (10f3) 200' SHEET NUMBER: 208 NE 4

NUMBER	R TYPE	PROBLEM	LOCATION
I	Storm drain System	System dosent (exist	College Heights Dr.
2,3,6	curb inlets	not shown on 200' sheet	Beechwood Rd. & Underwood Rd.
3	Storm drain pipe	pipe is PVC	Beechwood Rd.
5	manhole/F.C.	Storm clrains Connect within a manhole thats not locatable or a field connection not recorded.	Beechwood Rd.
7	outfall	none	wells Parkway
8	stormdrain system shown in	none	Beechwood Rd-g Underwood Rd.

Recommendation: accept entire system in Buehwood Rd for maintenance. WSSC repaired the pipe under Beechwood Rd. replacing broken pipe with PVC.

Remove dotted system on College Heights Dr. from 200' sheet.

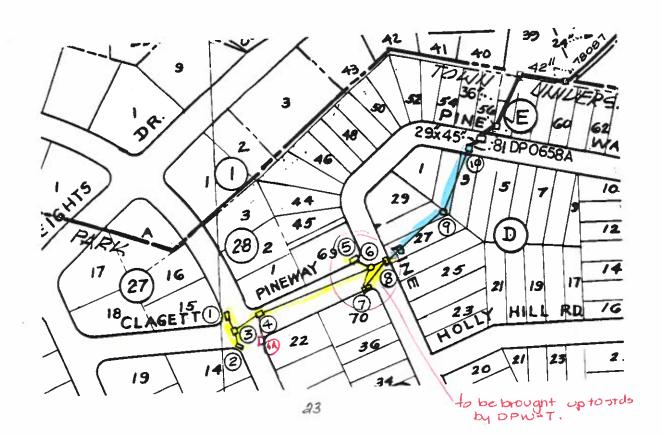
SUBDIVISION NAME University Park STREET: System in Clagett-Pineway, Pine Way (10f2) 200' SHEET NUMBER: 208 NE4

NUMBER	TYPE	PROBLEM	LOCATION
234	grate inlets	not shown on 200' Sheet	Clagett-Pineway & Clagett Rd.
5 7 8	curb inlets	not shown on 200' Sheet	Claget -Pineway &
6	manhole	not shown on 200' sheet	Pine Way

NUMBER	TYPE	PROBLEM	LOCATION
9	Yard inlet Storm drain from Structure 8 to 10	inlet has cracked, dosen't appear to be a Standard structure located on private property	
10	Storm drain	void in the yard indicating the posible of pipe failure	Lot 3 Pine Way

Recommendation: Accept system on Clagett-Pineway and Pine way located on public road. (Structures 1-8). Do not accept structure 9 and associated storm drain pipe located on private property. Structure 9 is substandard and broken. The storm drain pipe appears damaged and undersized due to location in sump area with inadequate 100 year overflow path.

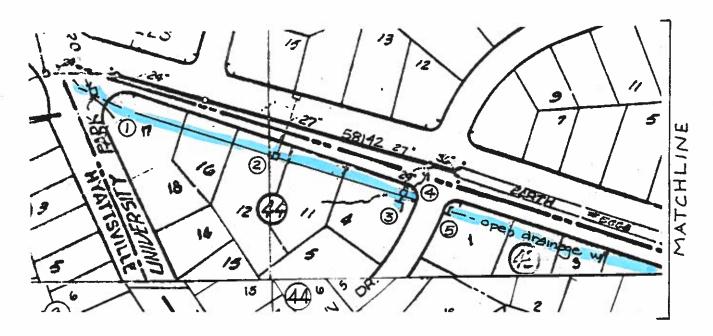
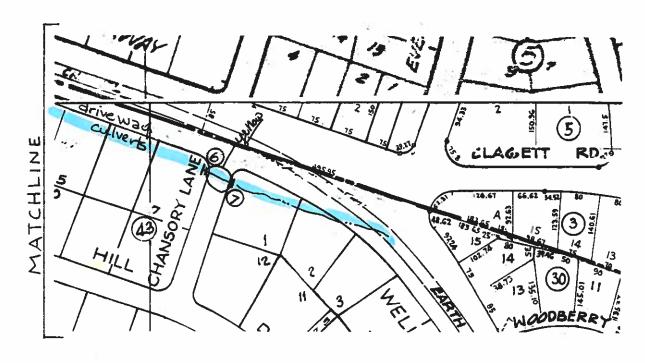
SUBDIVISION NAME University Park STREET: Wells Parkway (10f3)

NUMBER	TYPE	PROBLEM	LOCATION
1,,,	Branhole with D top in grassy area	see footnote	wells Pkwy
2	B manhole with D top on lot	see foot note	wells Pkwy
3,6	head wall	See footnote	wells Pkwy
4	manhole	see foot note	Wells Pkwy
5,7	endwall	see footnot	e Wells Pkwy

Footnote: Field investigation inducates system is located on private lots, most probably within 10' Public Utility Easement, not in the roadway as shown on the 200'sneet.

Recommendation: Accept entire system for maintenance provided system is located in public easement. The country will not occept the private driveway culverts crossing the open channel for lot access. Maintenance of the earthern channel will be limited to channel stability and adequate conveyance of Stormwater. Aesthetic maintenance including mowing will be performed by individual lot owners or the Town of University Park. If the open drainage is located on private lots without the recessary easements the country will not maintain the channel.

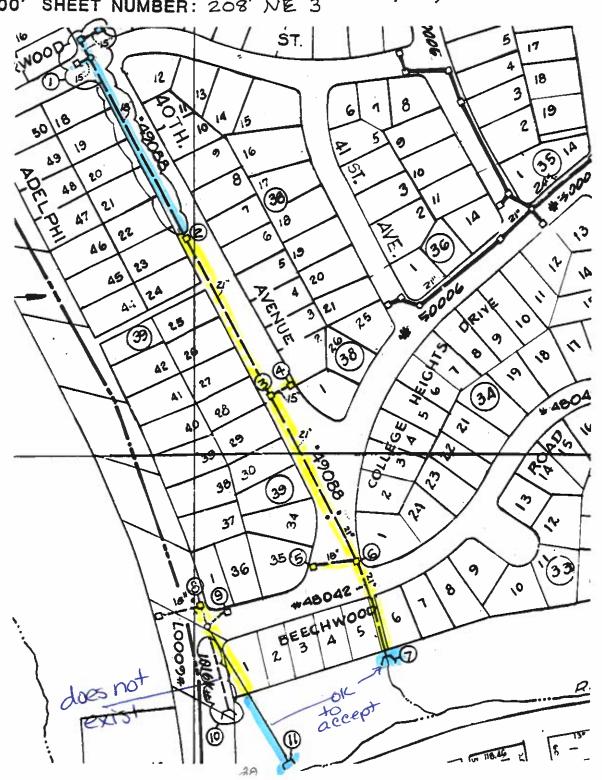
SUBDIVISION NAME University Park STREET: 40th Ave, Add phe Rd. (10f3) 200' SHEET NUMBER: 208 NE 3

NUMBER	TYPE	F	PROBLEM	LOCATION
1 5 e	Storm drain sys	Hen D	n dosenit exist upon field ins	40th Ave
	urb inlets	ı	no problem	40th Ave
	outfall	r has rep pur	no endwall; Town 5 modified to pair a pipe brain is exposed.	n Park prop. (Toledo Rd.) eak
8 cur	b inlets			Adelphi and Beechwood Rds.
10 stor encla	rm drain syste ised in CCC	m	not properly located on 200' Sheet	Park prop. (Toledo Rd.)
11 end	wall	no	problem	Park property

Recommendation: Accept entire system as shown except for outfalls 11 and 7. The outfalls are on parkland owned by the Town of University Park and lack the necessary Pasements for maintenance.

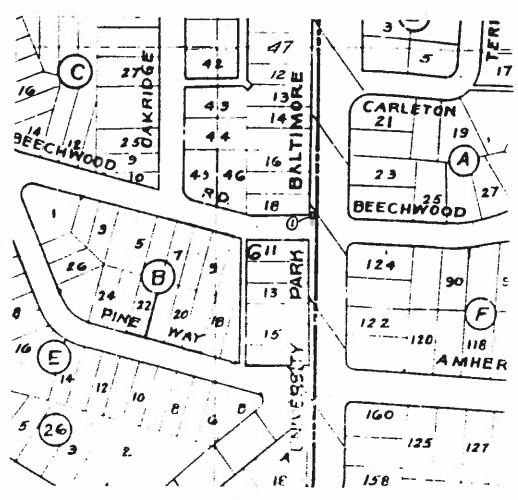
SUBDIVISION NAME University Parks STREET: Route 1 at Becchwood Rd.

1 grate inlet SHA RIW Rt 1 at Beechwood
Rd.

Recommendation: Inlet located in State R/W and will be maintained by the State of Maryland.

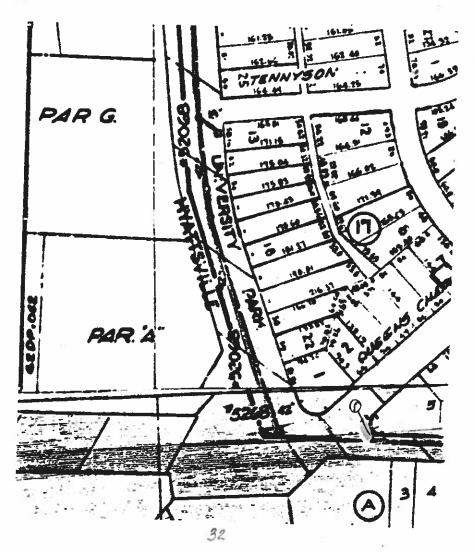
SUBDIVISION NAME University Park STREET: Route 410, Queens Chapel Rd.

wR inlet located in 410 R/W Queens Chapel Rd and Rt. 410

Recommundation: inlet trains 410 (state highway) and will therefor be maintained by the State of Md.

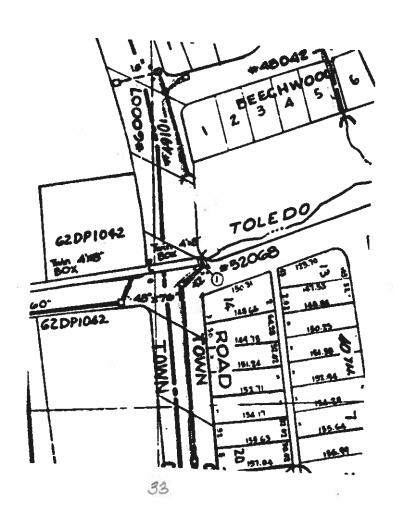
SUBDIVISION NAME University Dark STREET: Adelphi Rd.

LOCATION PROBLEM NUMBER TYPE inlet Inlet field connects none into box culvert on Adelphi Rd.

Recommendation: Accept inlet for maintenance.
